# North Bay Courthouse restoration uses lateral force-resisting system

Dan O'Reilly December 17, 2018

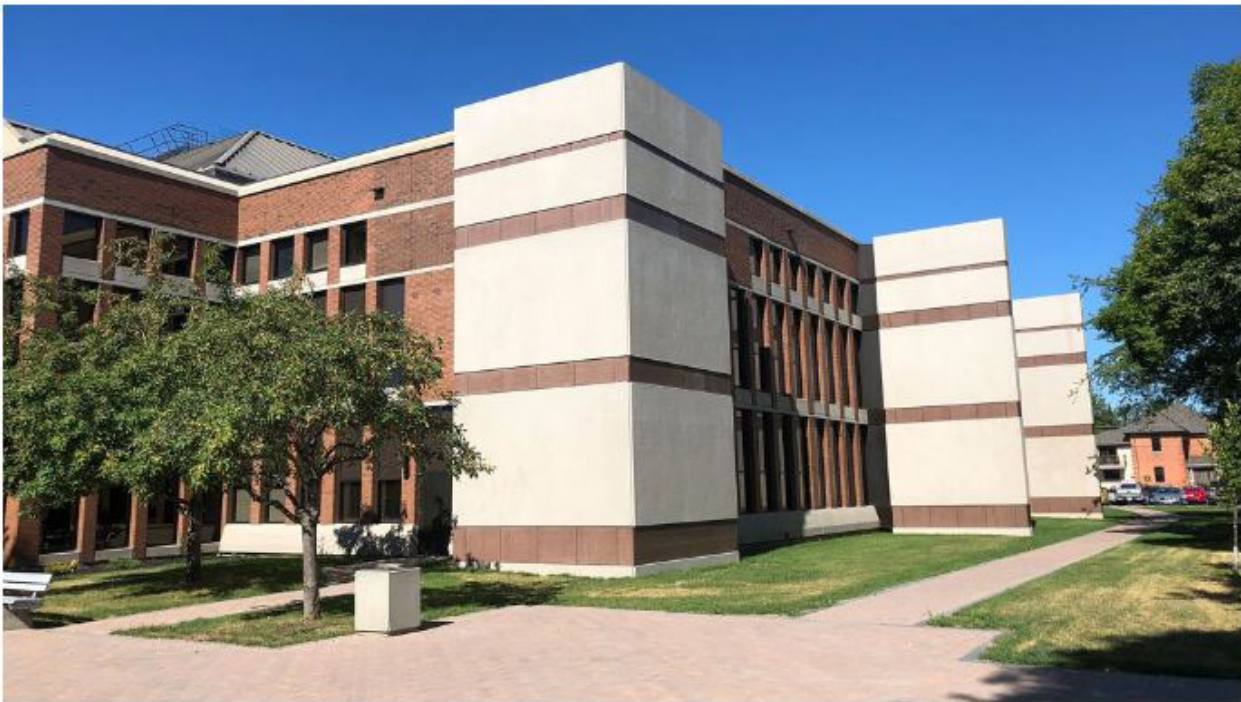
PHOTO COURTESY OF READ JONES CHRISTOFFERSEN LTD. — Pictured is an overview of new precast shear walls along the north elevation of the North Bay Courthouse Building. External precast shear walls were utilized as part of the lateral force-resisting system for the building's seismic upgrade project.

Over a 23-month period from December 2015 to October 2017 North Bay, Ont.-based Kenalex Construction Company Ltd. erected 13 full-height reinforced precast concrete shear walls around the perimeter of the building and structurally reinforced the interior steel framing and slab connections to transfer seismic loading to those walls.

Ultimately the design team selected option four, the installation of 13 strategically placed precast concrete shear walls and the interior steel frame reinforcement. Essentially exterior steel connector beams or horizontal trusses — depending on the location of the shear walls — connect with the interior steel beam drag struts, he explained.

In his PowerPoint presentation Van Zwol showed how that esthetic objective was achieved through the use of coloured three-inch-thick architectural granite panels that hide the construction joints and grout ports and match the existing brick masonry. The shear wall concrete was also pigmented and sandblasted to match the colour of the existing window precast bands.

Comprised of approximately 39 wall panel sections each, the shear walls were installed at night over a two-week period to avoid interfering with court operations and to mitigate the impact of road closures. Several of the precast walls were required to be oriented perpendicular to the face of the building and act as buttress walls. This was required in order to provide adequate lateral resistance evenly around the perimeter of the building, he said.
