PERFORMANCE PANDEMONIUM: Designing and modifying the ETFE skylight system for the Calgary Zoo's Panda Passage Exhibit

By Jelena Bojanic, BSc, P. Eng, Project Engineer, Read Jones Christoffersen Ltd.

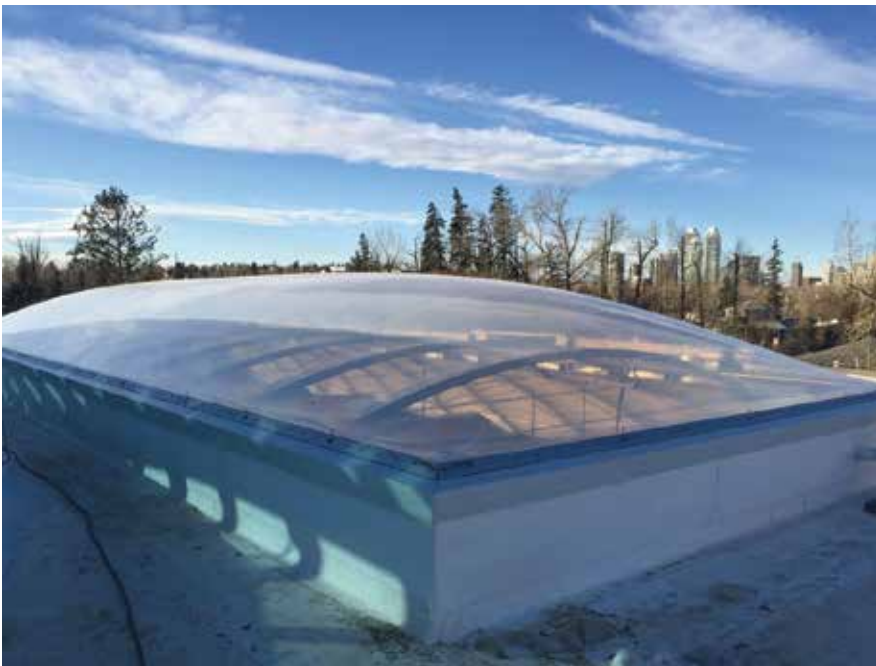
The panda exhibit ETFE skylight at the Calgary Zoo.

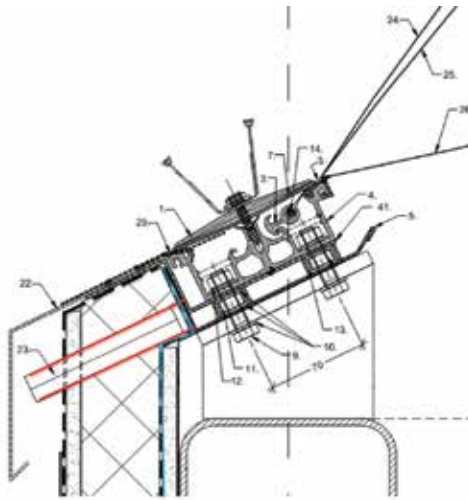
The air barrier plane for the ETFE system relies on multiple components, including the ETFE foil, the ethylene propylene diene monomer (EPDM) edge gasket, the EPDM cover gasket and the air barrier membrane tied from the aluminum profile to the existing roof deck. The manufacturer’s shop drawings had inherent air barrier and drainage flaws. The design showed a condensation gutter that drained externally through the air barrier membrane (Figure 2, part 23) via four drain pipes, two on each of the east and west elevations, and none on the south and north elevations. The drain pipes were positioned at quarter points with a large spacing. A metal sheet section was shown to extend from the underside of the aluminum profile to the exterior sill (Figure 2, part 41) creating thermal bridging within the assembly.

Figure 2: Section through the ETFE system with external drainage (red line) through air barrier (blue line). (Image imported from ETFE manufacturer's shop drawings¹.)

incorporate pressure equalization and internal drainage without impacting the air barrier or resulting in thermal bridging. RJC suggested that the above items be revised as they were not acceptable per industry standards. The proposed spacing between drain pipes was likely inadequate for water to access and expel out of the system and should be revised. The sill should be water and air-tight, with no unsealed openings through the air barrier. We suggested providing internal drainage if draining to the exterior was not a possibility without affecting the air barrier. The metal sheet (Figure 2, part 41) was to be modified to eliminate the thermal bridge through the skylight sill.

cushions were noted. One of the first obvious issues was the inadequate gap at the mitered corners. The aluminum profiles were misaligned such that the coupling surfaces at the corners were offset from one another. The misalignment was partially due to the aluminum profile not being set true and level. The structural steel below the aluminum profile was not perfectly level, and the aluminum profile did not incorporate adjustability (i.e. levelling nuts or incremental shims). The suggested improvement was for the contractor to adjust the positioning of the aluminum frame by using adjustable levelling bolts/nuts, see parts 9, 10 and 12 in Figures 2 and 3.

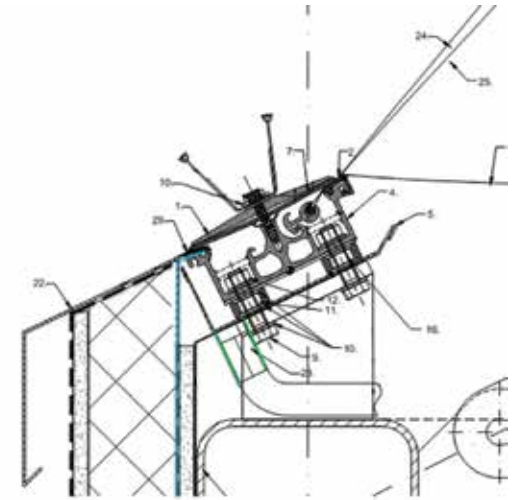
Figure 3: Revised ETFE system with internal drainage (green line) and air barrier detail (blue line). (Imported from ETFE manufacturer's shop drawings¹.)

intended to provide support for the roof membrane tie-in. The final design included tying the air barrier into the aluminum profile, creating a continuous air barrier plane. Figure 3 shows the revised section of the system.

The manufacturer revised their design following most of RJC's recommendations. Internal drainage was provided through the condensation gutter and directed to the interior panda space. The layout of the drain pipes was not changed during design revisions. Thermal bridging was mitigated by removing the metal sheet section

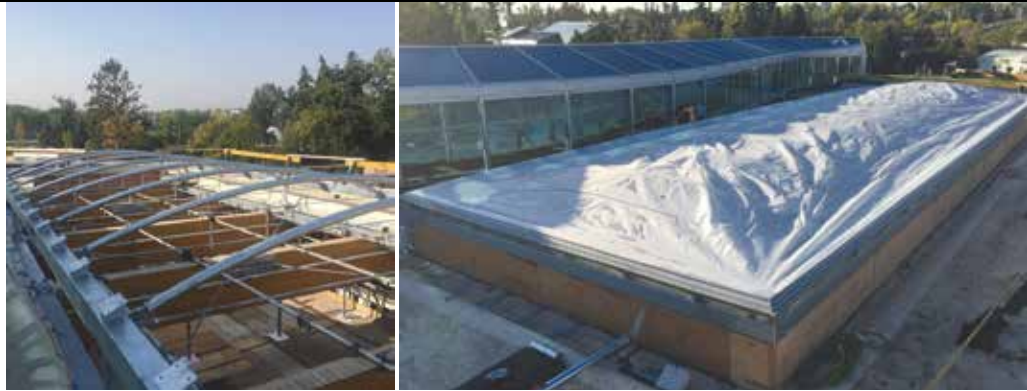
Far right: ETFE skylight above panda exhibit being inflated with a blower.

Right: Steel frame structure for ETFE skylight with steel arches, beams, columns and tensioning rods.

is supported by steel pipe arches that are fastened to steel perimeter beams made of square tube sections. The beams are further supported by steel columns also made of square sections. Tension rods are incorporated throughout the frames to mitigate deflection of the structure.

Once the ETFE cushions were attached to the aluminum profile they were inflated with the blower. Each skylight was inflated in approximately one hour, with minor adjustments required for the EPDM edge gaskets, which were displaced during ETFE install.
