# REPAIRING AND PROTECTING A 1950s ERA WASTEWATER DIGESTER TANK

By Leigh Besanger and Daryl Prefontaine

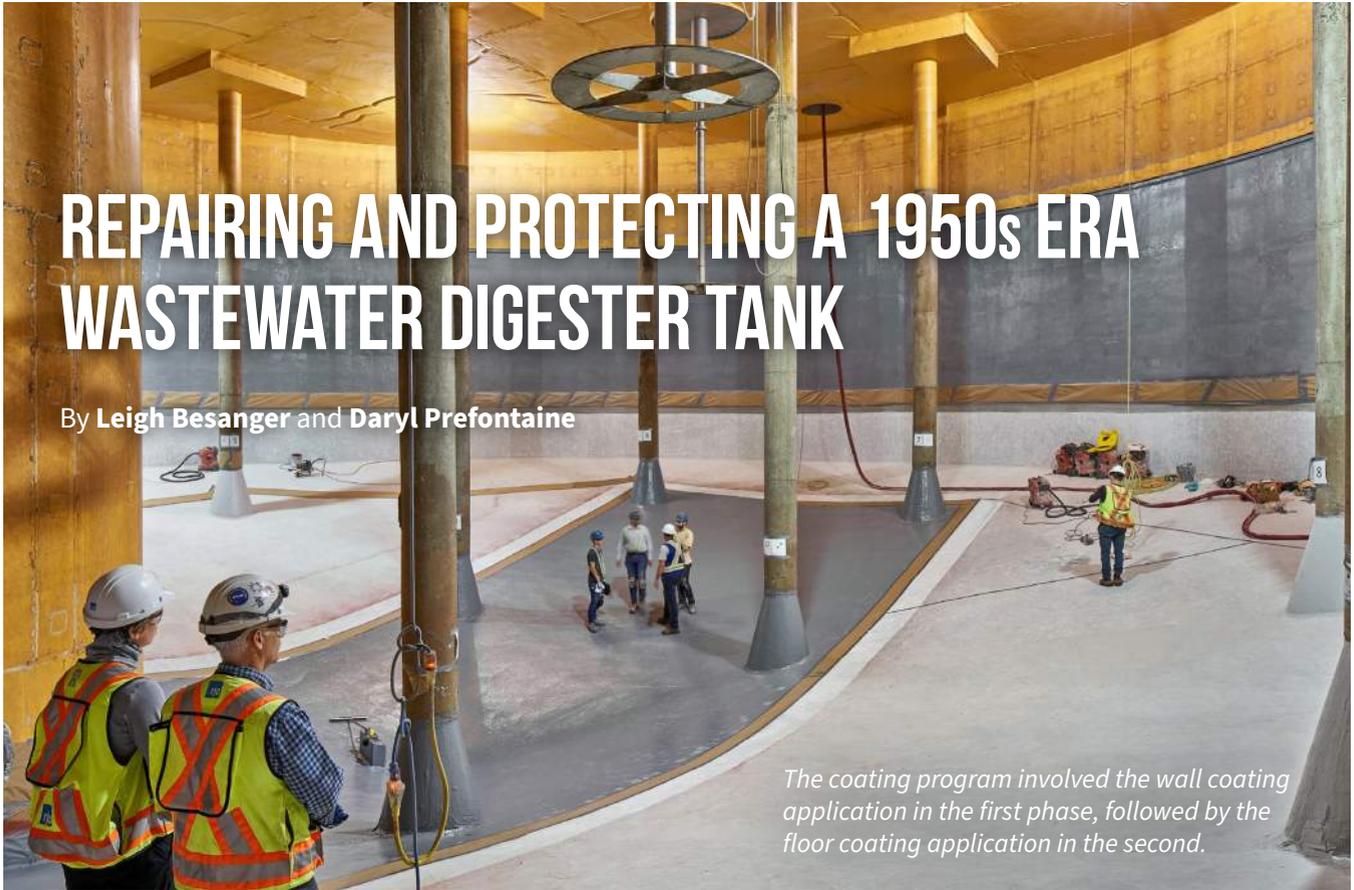
*The coating program involved the wall coating application in the first phase, followed by the floor coating application in the second.*

The coating program involved the wall coating application in the first phase, followed by the floor coating application in the second.

Scaffolding was constructed inside the digester for the cleaning, repair, preparation, and coating application on the lower seven vertical metres of interior wall surface (existing HDPE on the upper 2.5 metres).

Once the wall coating application was completed, reviewed and tested for conformance with project specifications, the scaffolding was deconstructed and floor surface cleaning, repair, preparation and coating application phase proceeded.

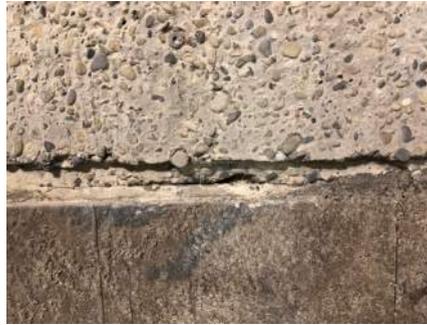
During this initial review, concrete cracking, cold-jointing, loose form-tie hole plugs, large areas of poorly consolidated and non-encapsulated aggregate (honeycombing), and void-ridden pour-joints with debris embedded at the interface were visually identified.

*Voids and debris at pour-joint (bare concrete above joint, existing coal tar coating below).*

- Fully remove the existing coal tar coating and any potential wastewater-related contaminants from the substrate surfaces.
- Remove and repair all areas of unsound concrete, including poorly consolidated and non-encapsulated aggregate to provide a suitable substrate for coating application.
- Fill, patch, and repair all surface voids, including localized injections of expand-

ing polyurethane grout at pour-joint interfaces.

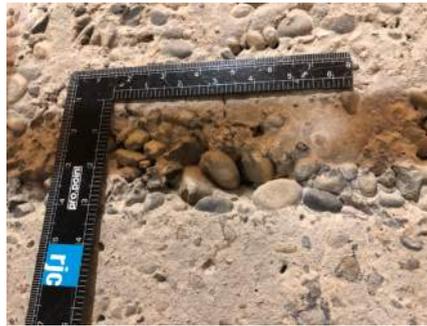
*Poorly consolidated and non-encapsulated aggregate.*

Loose, non-encapsulated aggregate was then chipped away from the surface and patched. An epoxy mortar mix was applied to resurface and reprofile the substrate, which effectively filled all of the “peaks and valleys” of the abrasively blasted concrete. This pre-manufactured epoxy mortar mix was trowel applied to the surface to provide a uniformly textured substrate similar to CSP 3, which was the required surface profile for this coating application.

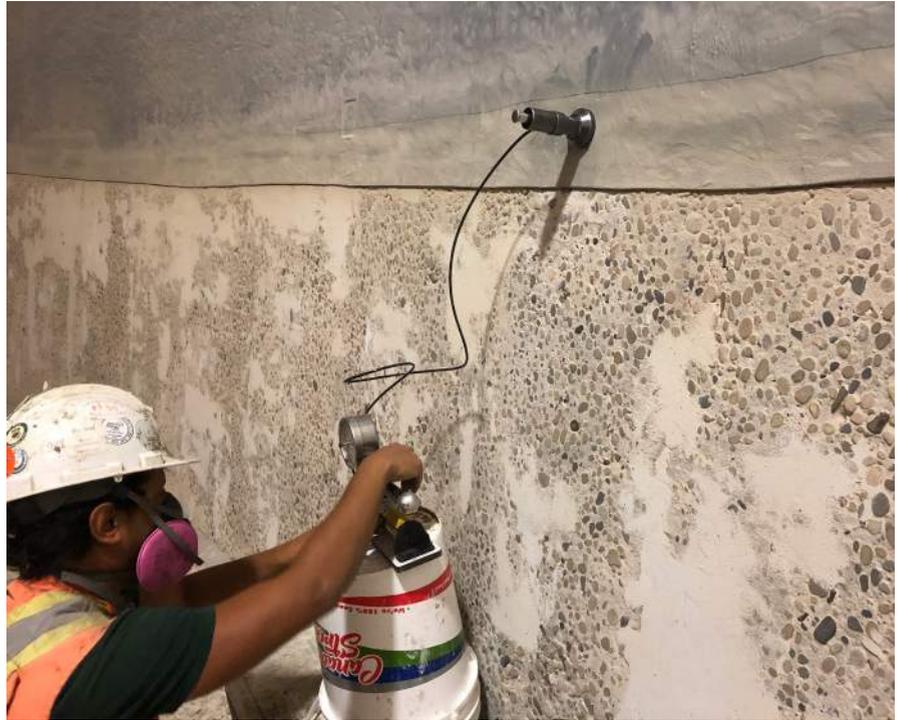
Quality Assurance testing – adhesion strength pull-off testing.

In addition to the contractor's quality control, quality assurance testing was performed that included adhesion strength pull-off testing and holiday/spark testing by the consultant and third-party testing agencies. After each round of holiday/spark testing, pin-hole and coating discontinuity repairs were performed and retested.

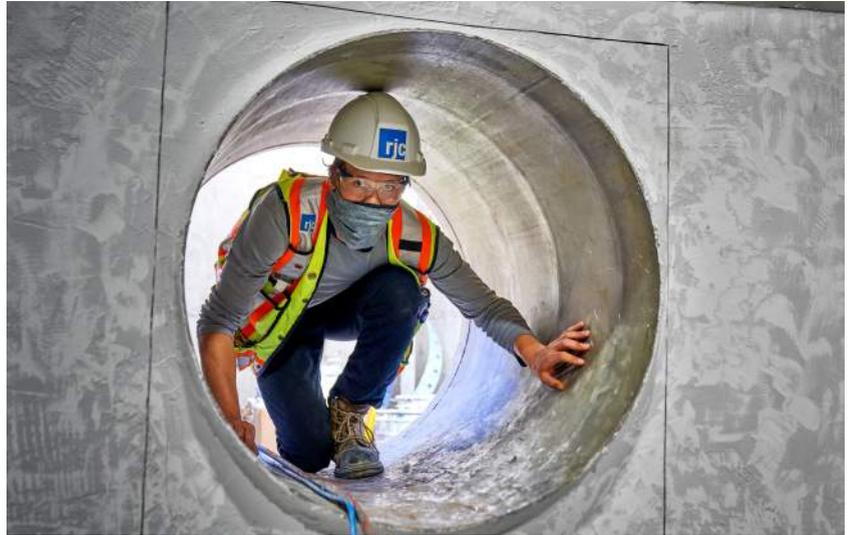
However, WWTP repair and rehabilitation programs are never without site-specific surprises, so design and construction challenges were welcomed as learning breakthroughs. For instance, access to the digester interior was limited to a single 900-mm diameter access hatch, located below ground level. This meant that workers, materials, access scaffolding, and equipment passed through this small opening countless times during the project.

There was only a 900-mm diameter access hatch into the digester.

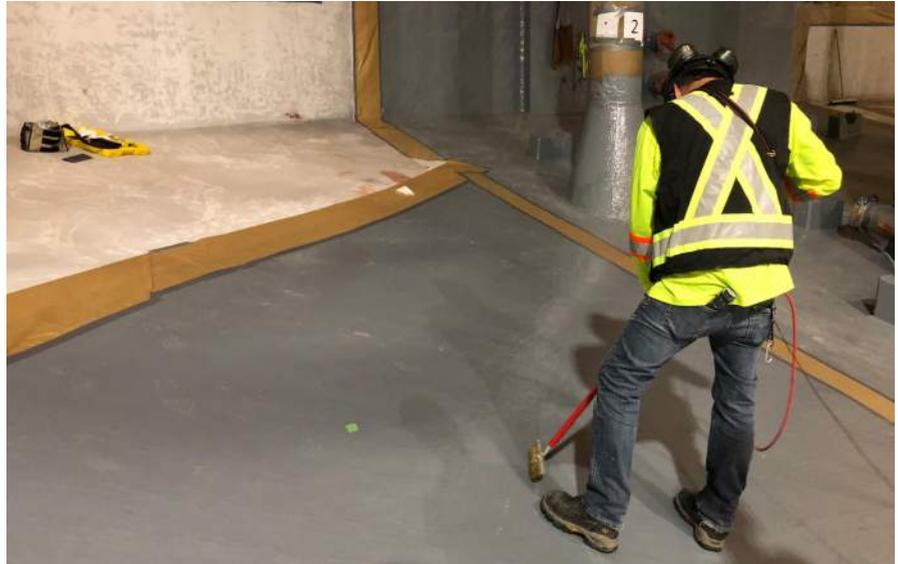
After each round of holiday/spark testing, pin-hole and coating discontinuity repairs were performed and retested.
