THE ARCHITOURIST

The tower that once topped Toronto shines again

DAVE LEBLANC >

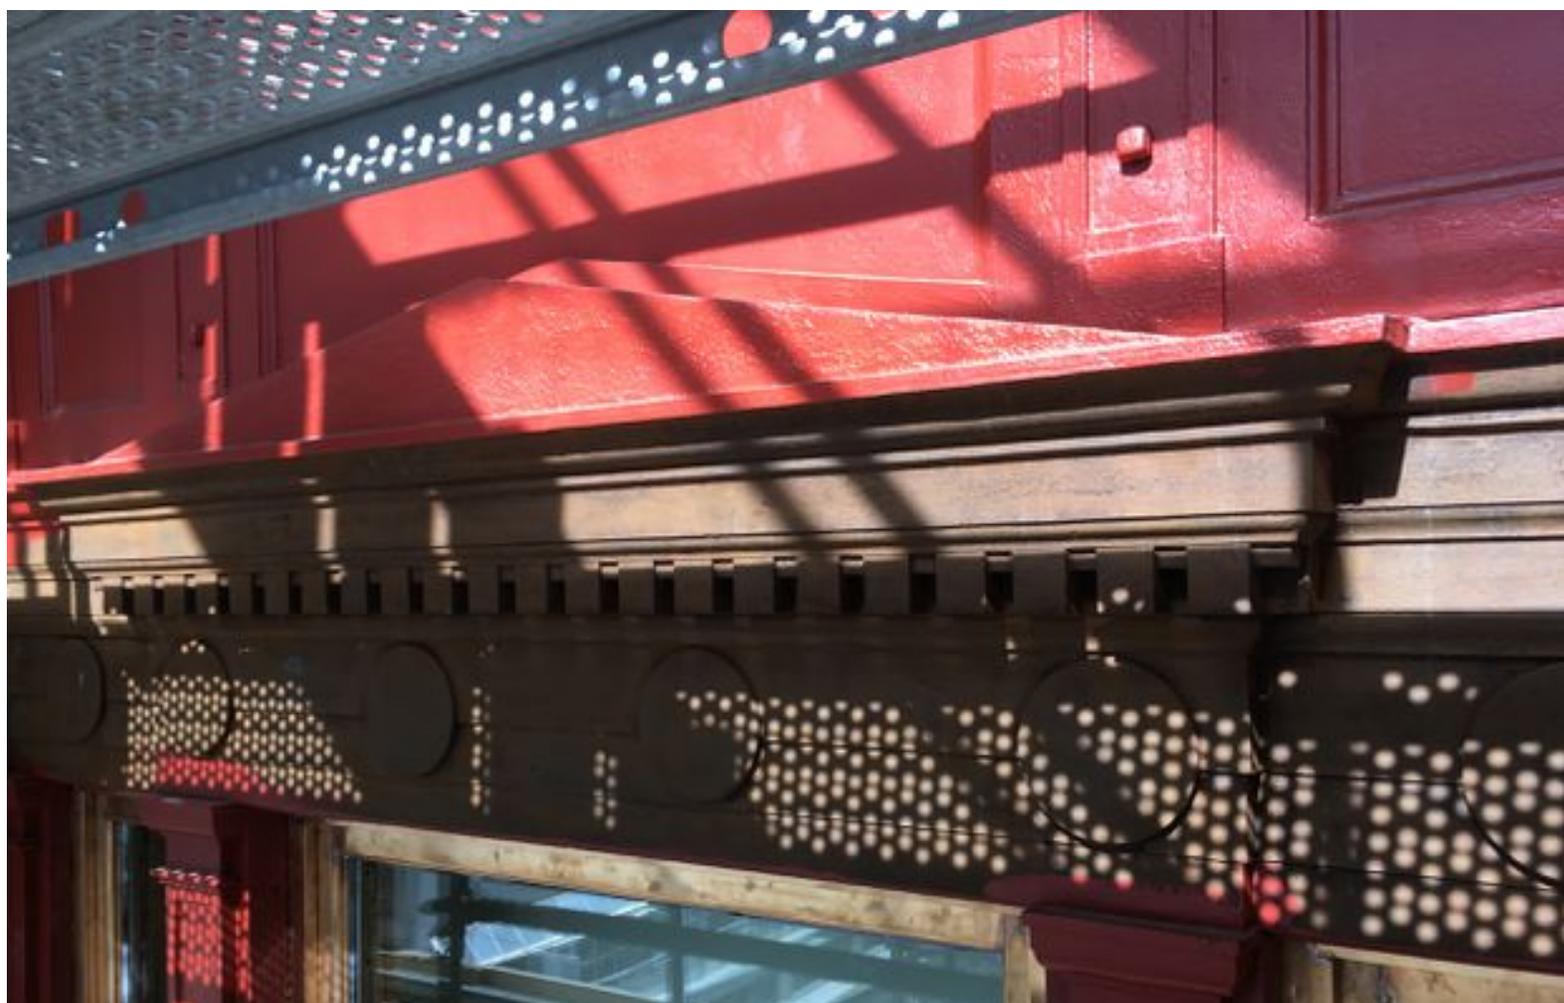
Oxblood paint going on temple during the renovation.

On the 16th, 17th, and 18th storeys, what were “piles of rusty metal” around each window-set have now been restored to “mini temples” with pediments and pilasters painted a period-appropriate oxblood red. Soft lead flashing now protects sills and lugs like a “suit of armour.”

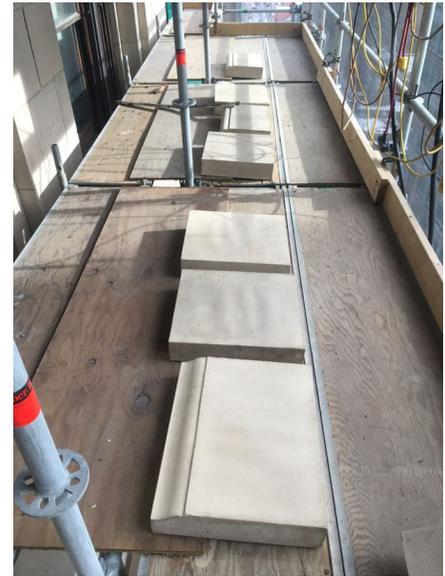
New terracotta ready for installation during the Royal Bank building renovation.

Something else that might have been lost was the acanthus leaf ornamentation from the columns. Chunks of the plaster, mortar and terracotta block had fallen to the street in years past, prompting the city to order the property owner to wrap them in chicken wire. The terracotta block, incredibly, had been fastened to the building's steel frame by wrapping wire around it and then slapping mortar over top. This ad hoc approach, Mr. McGillivray explains, happened for only a short while during the "overlap" between traditional masonry construction and modern steel buildings. "They were working it out as they went," he says, "having one foot in the 20th century and the other in the 19th century with Beaux-Arts detailing."

Of course, as much of the original terracotta and acanthus ornamentation that could be saved was, and then remounted, in situ, with new high-strength brackets. But in cases where deterioration was too great, ERA and RJC found a local shop to make a mould – complete with the vertical tooling marks found on the originals – for the 337 reproductions that were needed. For some of this work, the two firms consulted with Chicago-based engineer Amy Lamb Woods, an expert in terracotta, brick, stone, terrazzo and stucco.

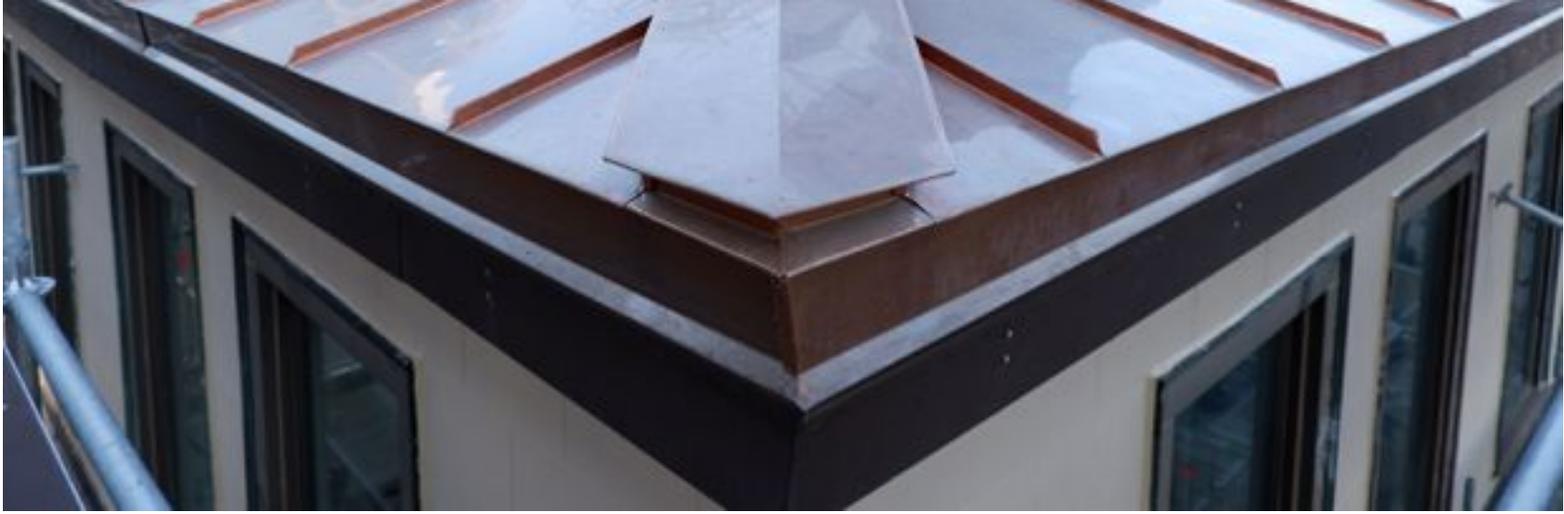
New copper penthouse roof.

Even at the very top things didn't look good, says ERA project manager Noah McGillivray: "Instead of repairing [the roof] through the century, they just re-clad over it, trapping moisture; it was rotting, the whole roof, so we did have to take the whole thing apart ... profile all the details, match them exactly, and then recreate them in copper."

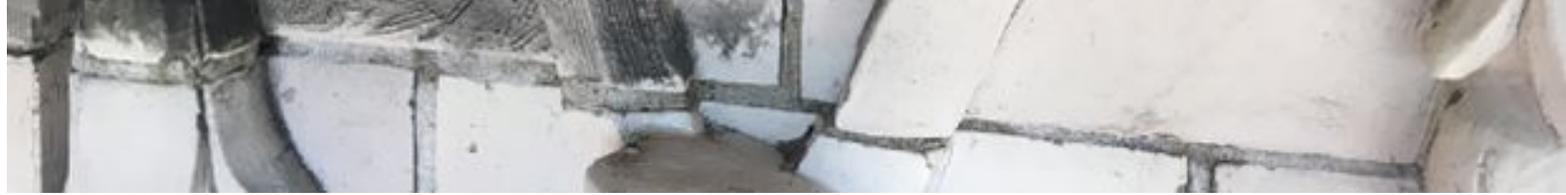
Uncleaned portion vs. cleaned portion is seen during the renovation.
