# Preserving Older Buildings

## Conservation best practices for heritage property owners

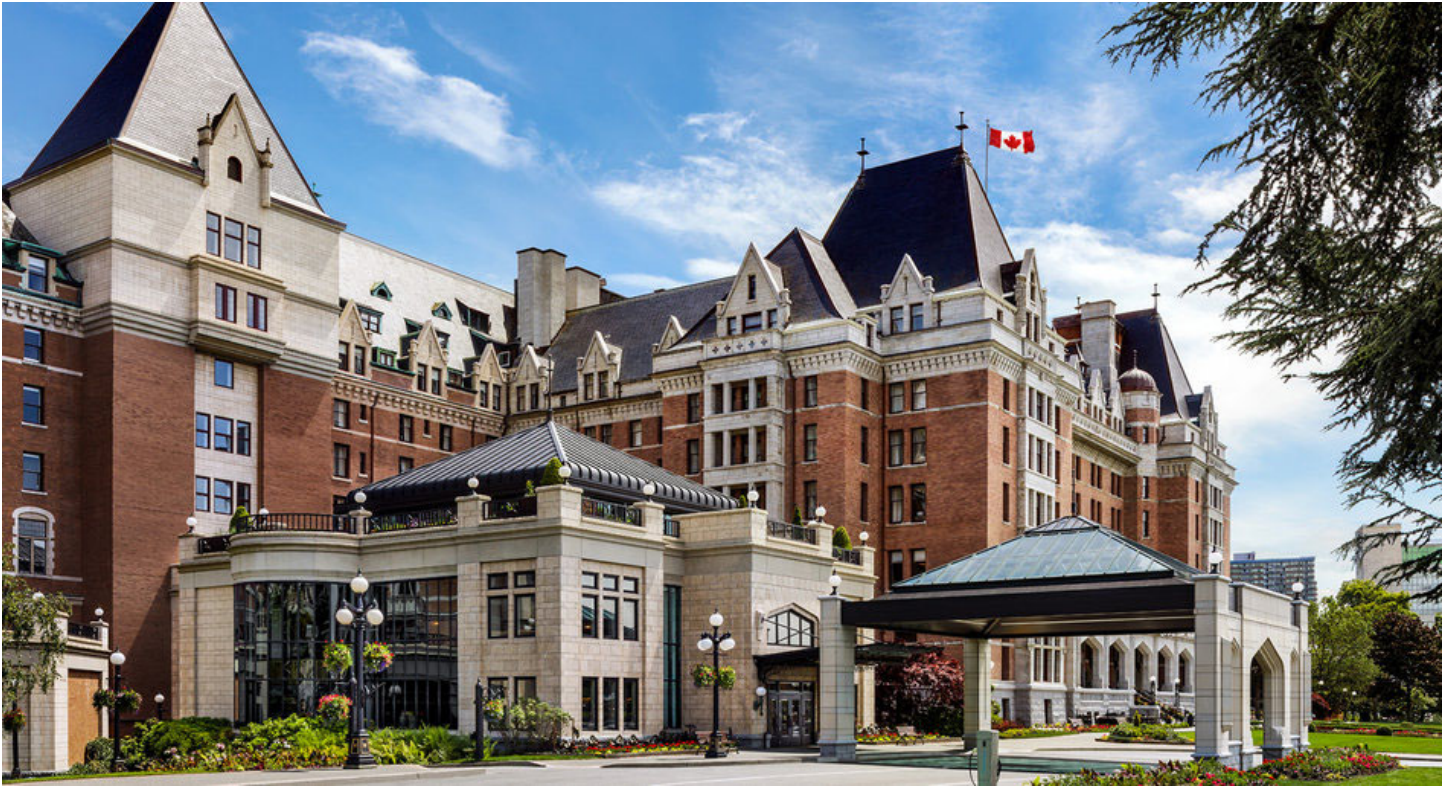
In the case of the example above, it was obvious to Glade that the contractor had made erroneous use of a cup-stone on an angle grinder operated by hand to resurface the stone, which led to chawed uneven surfaces. “Assuming the stone actually required resurfacing, hand grinding a vertical surface was never going to result in a smooth finish. A smooth finish could have been achieved with a wall mounted jig,” he says.

“It was made of Andesite, a type of building stone commonly used in the early to mid part of the last century,” he says. “Like sandstone and limestone, this material is great but it is prone to deterioration in the form of exfoliation over long periods as the moisture moves through the stone and evaporates just beneath the natural patina of the stone, leaving behind a build-up of minerals.” Glade explains that this build-up of minerals exerts localized pressure on the back surface patina causing it to exfoliate. The repetition of the process is the deterioration of the stone.

While the natural wetting-drying process cannot always be avoided, Glade asserts that the best conservation approach is to simply intervene as little as possible. “With andesite, it is difficult to replace whole blocks. The best approach is to scale the loose material off and manage the water by deflecting or applying a water repellent,” he notes.

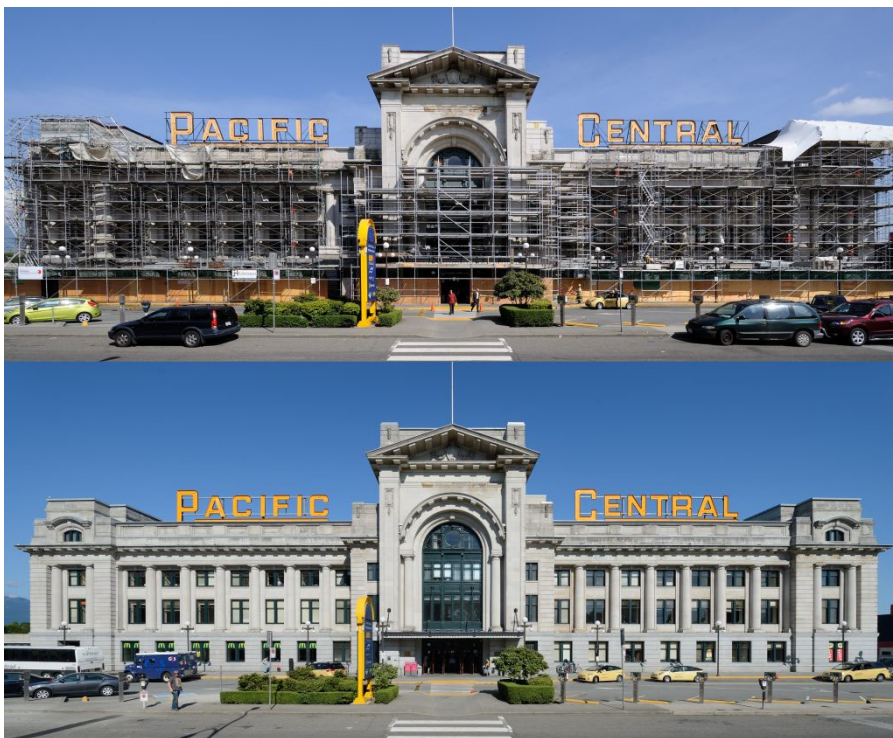
When it comes to heritage conservation, Glade advocates taking the “less is more” approach and only intervening when necessary—and for Andesite the first step is small, localized repairs. Using a scraper to scale away problematic areas and managing the water is what he calls the first level of intervention. After that, some stones may require “Dutchman” repairs, or a step further being whole stone replacement.

“Before launching any repair work, seek out trusted heritage conservation specialists and contractors who are experienced in working with older materials,” he says. “Ask for a mock-up, a sample of the treatment, so you can review the results before committing to a method of repair. It is important to note that the existing stones, having been out in the weather for more than 100 years, will not match for several years.”
